THE FRAMEWORK FOR DISMANTLING AND REINSTALLING WORKS OF MALAY TRADITIONAL TIMBER BUILDINGS BASED ON MALAYSIAN CASE STUDIES

*Afzanizam Muhammad¹, Shaari Mat Saod², Norashikin Abdul Karim³ & Nurajwani Abdul Halim⁴
^{1,3,4}Universiti Teknologi MARA, Perak Branch, Malaysia & ²NTQT Sdn Bhd.

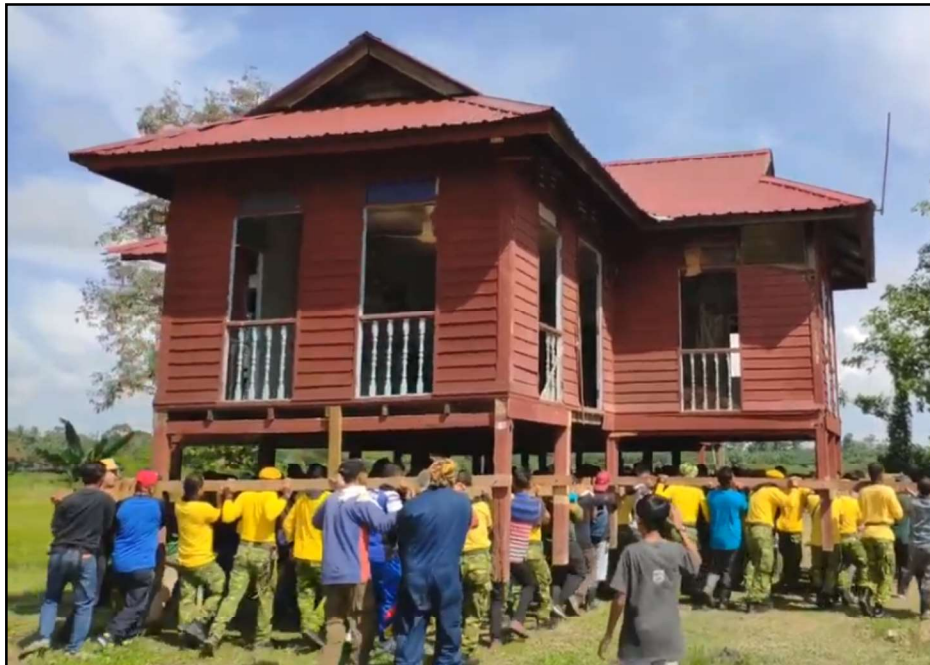
Figure 1: lifting to shift the Malay house by manpower in Kampung Baru, Bota Kanan, in Perak State
Source: Faazawanz (2018)

In old Malays, cultural ritual is performed either fully or partially dismantling a building or house which intended to be moved. Partial dismantling is usually practised to reduce the weight of the house so that it can be lifted to move with manpower. Houses completely lifted using manpower are known as the customary practice of '*angkat rumah*' or '*pindah rumah*', commonly practised for small ones and relocation within a short distance (Yuan, 2002). However, rare cases, such as heritage Mosques and palaces, have undergone reinstallation at a new site in Malaysia. The common practice of reinstalling a traditional building built from timber involves the basic process of dismantling, transporting, repairing or replacing, and reinstalling at a new location with minor new components as a replacement of damaged ones (Killman et al., 1994).

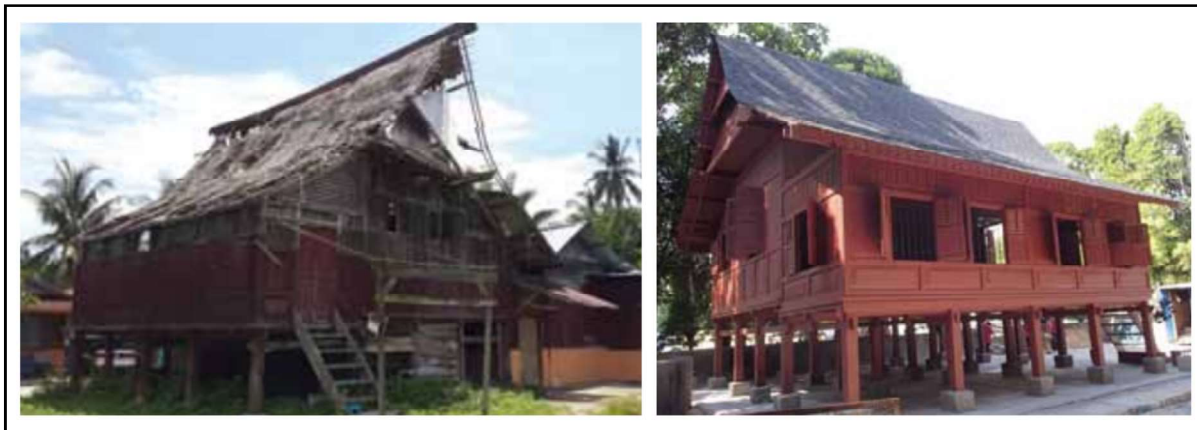
Figure 3: The Bugis house in 2014 was left abandoned (left), and the same house after reinstatement work was completed (right).

Bugis house, also known as the Red House, was owned by a Bugis chieftain (*penghulu*) and was built around the early 1900s. The traditional timber house was erected and decorated with features and elements of the Bugis ethnic identity. The initiative aims to rescue, restore and relocate the house from Kampung Permatang, Kuala Selangor, to the grounds of the Sultan

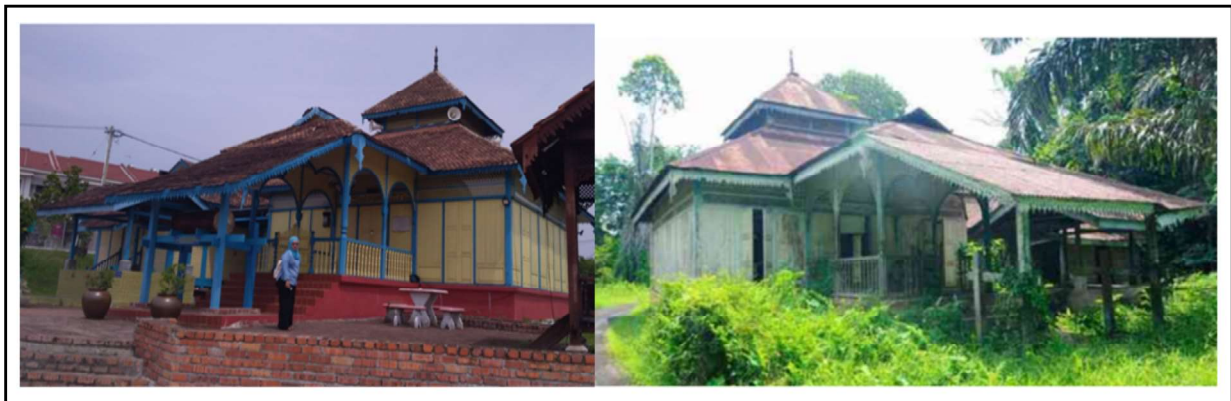
Figure 5: Kampung Teluk Memali Old Mosque found in the original site before reinstallation (left)Source: Zulkarnain (2019) and the mosque at the new site after reinstallation work in 2018 (right). Source: Author, 2018

(Zulkarnain, 2019). The reinstallation work to the mosque in 2016 has been relocated to a new site in Ipoh, Perak. Based on historical studies, the mosque built before 1900 was moved to the same village in 1910 due to often flooding from river overflow and the risk of riverbank erosion (Mamat, 2018). A visit to the new site in 2019 found that the relocation work was fully completed retaining the original local design features and uses as the original function. In Malaysia, originally in the old days, the purpose of dismantling and reinstalling the building by Malays is due to the new place of settlement and the development of family members due to marriage. But today, the reinstallation of heritage buildings in Malaysia is widely practised to safeguard valuable buildings. At one time, the building was built at the original place to suit the needs of the current time. Still, the time changes caused the area to be increasingly abandoned for several reasons, such as economic development, social factors, and natural disasters.

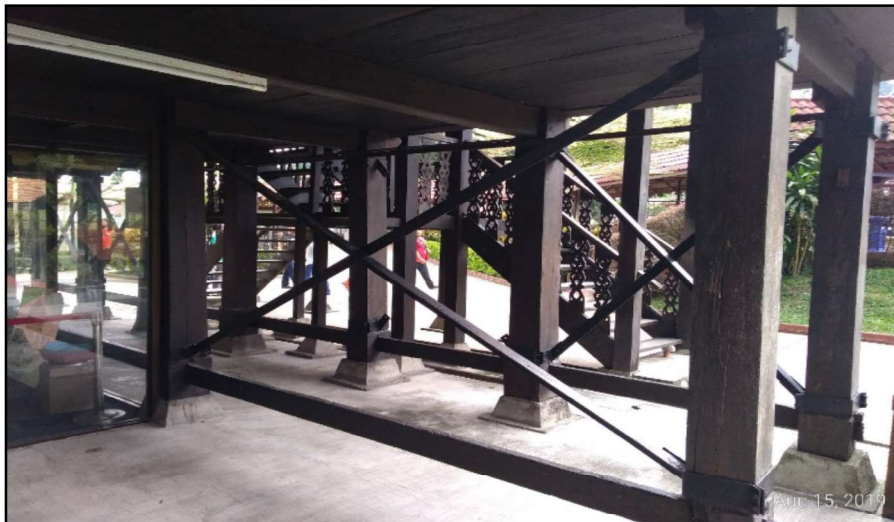
Figure 7: Consolidation by steel braces on the columns of Istana Satu, which was once reallocated to the National Museum compound.

The reinstallation work starts with the building's main structure and roof structure, followed by other non-structural elements. The building underwent partial dismantling, where the main structure remains intact; the reinstallation work proceeded with the joist and floorboards first. In historic timber building conservation, reinstallation always reflects the original building. At this stage, the recorded data, such as measured drawings and the collected pictorial evidence, is referred to. However, some buildings that moved need to add a consolidation element to increase their strength and rigidity. Some buildings have changed from their original function (adaptive reused) and need to undergo consolidation because they are expecting to receive more loads than before. Consolidation usually involves foreign materials than the original (Feilden, 2003). Based on the case studies, the consolidation involves using steel structures and additional timber that match the existing species or at least the same in strength groups.

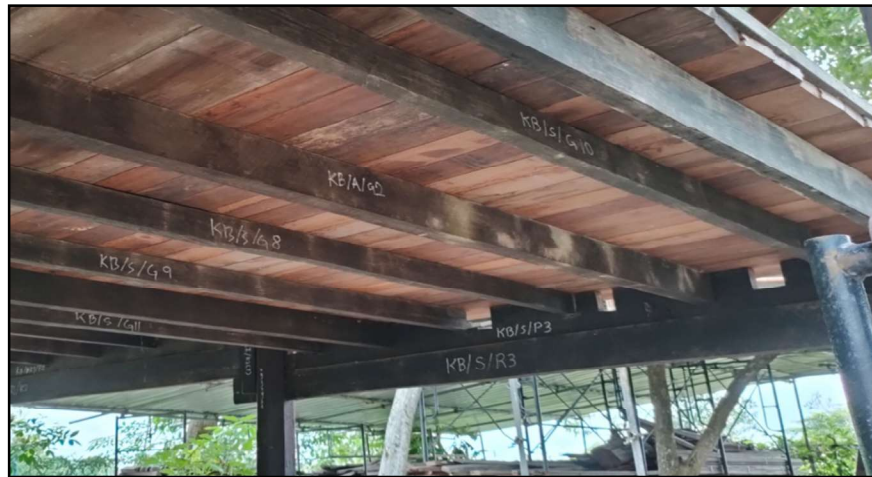
Figure 8: The members below the raised floor marking left to remain as work evident and for future reference.

After the reinstallation work is completed, the temporary component marking is cleaned to receive the new coating (finishing). In a particular area not exposed, such as under the raised floor, the reinstallation marking remains as work evident in the future. The new coating proposed is always modern to ensure long-lasting protection for the timbers, but the colour selection that matches the original is the first choice. The timber coating that exposes the timber grain pattern is most popular in traditional buildings in Malaysia. Finally, is to label the
